McMartin

Scientific

Report

THE TUNNELS FOUND AT THE McMARTIN PRE-SCHOOL
A PRELIMINARY REPORT

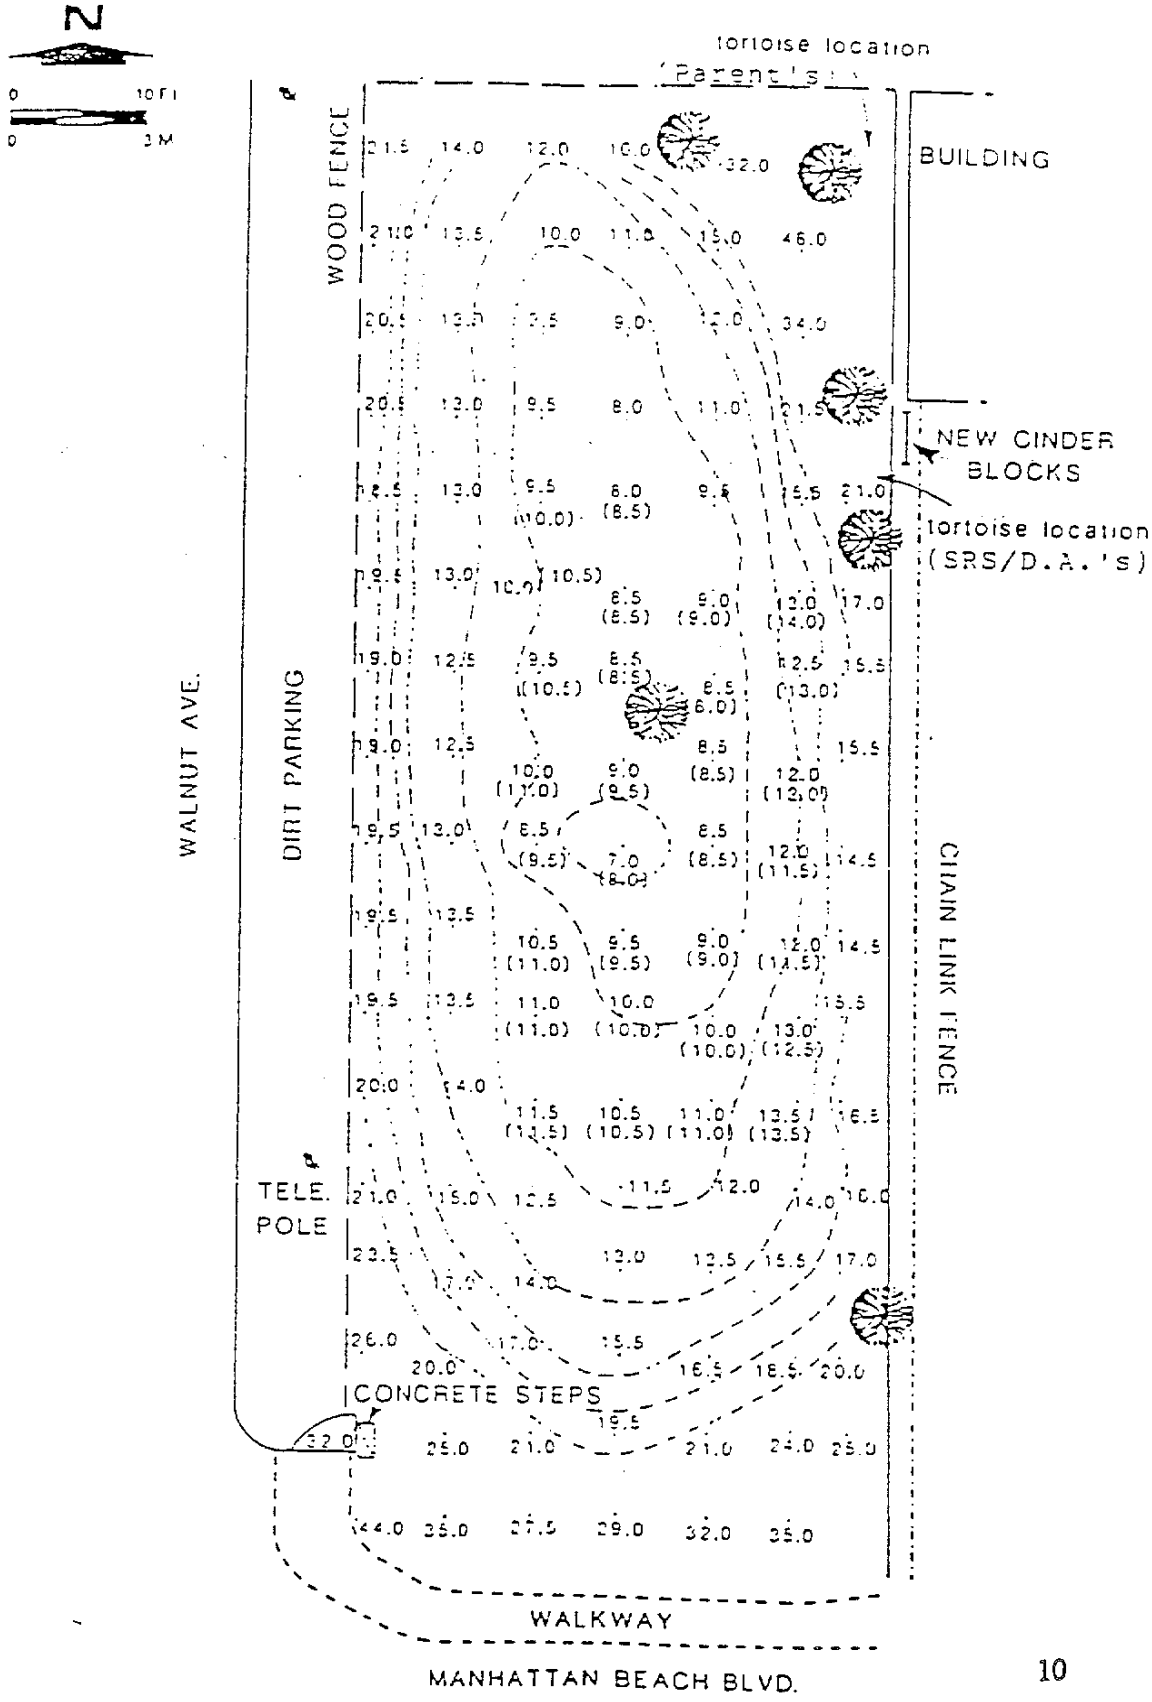
FIGURE 3: DISTRICT ATTORNEY'S 1988 ARCHAEOLOGICAL REMOTE SENSING SURVEY MAP OF THE SIDE LOT WITH ELECTRONIC READINGS (Note 1 Anomalies Indicated)

With better data, two anomalies were detected in the side lot by the geophysical survey (see Figure 3). These were:

> . . .(a) curving linear anomaly near the middle of the lot, adjacent to the south and southwest sides of the large rubber tree. . . . this anomaly lay at a depth of 3.6 m. (ca. 10-19.5'). There was no clear indication of how the anomaly should be interpreted. A second anomaly was found at the eastern edge of the lot next to the McMartin Preschool fence in the vicinity of the large bush, an area where some witnesses alleged that animals had been buried. (This was interpreted as) . . . a probable indication of slightly altered ground conditions, but (the geophysicists) could not offer a more detailed explanation (Langenwalter, *et al*, 1985: 19-21).

Despite these indicative findings and the recommendations of the archaeologists to excavate and identify the anomalies, the District Attorney's Office did not pursue these possibilities (Langenwalter, 1992b: personal communication). Consequently "The anomalies targeted by the terrain conductivity meter were not excavated and, therefore, their exact nature remains unknown" (Langenwalter, *et al*, 1985: 19).

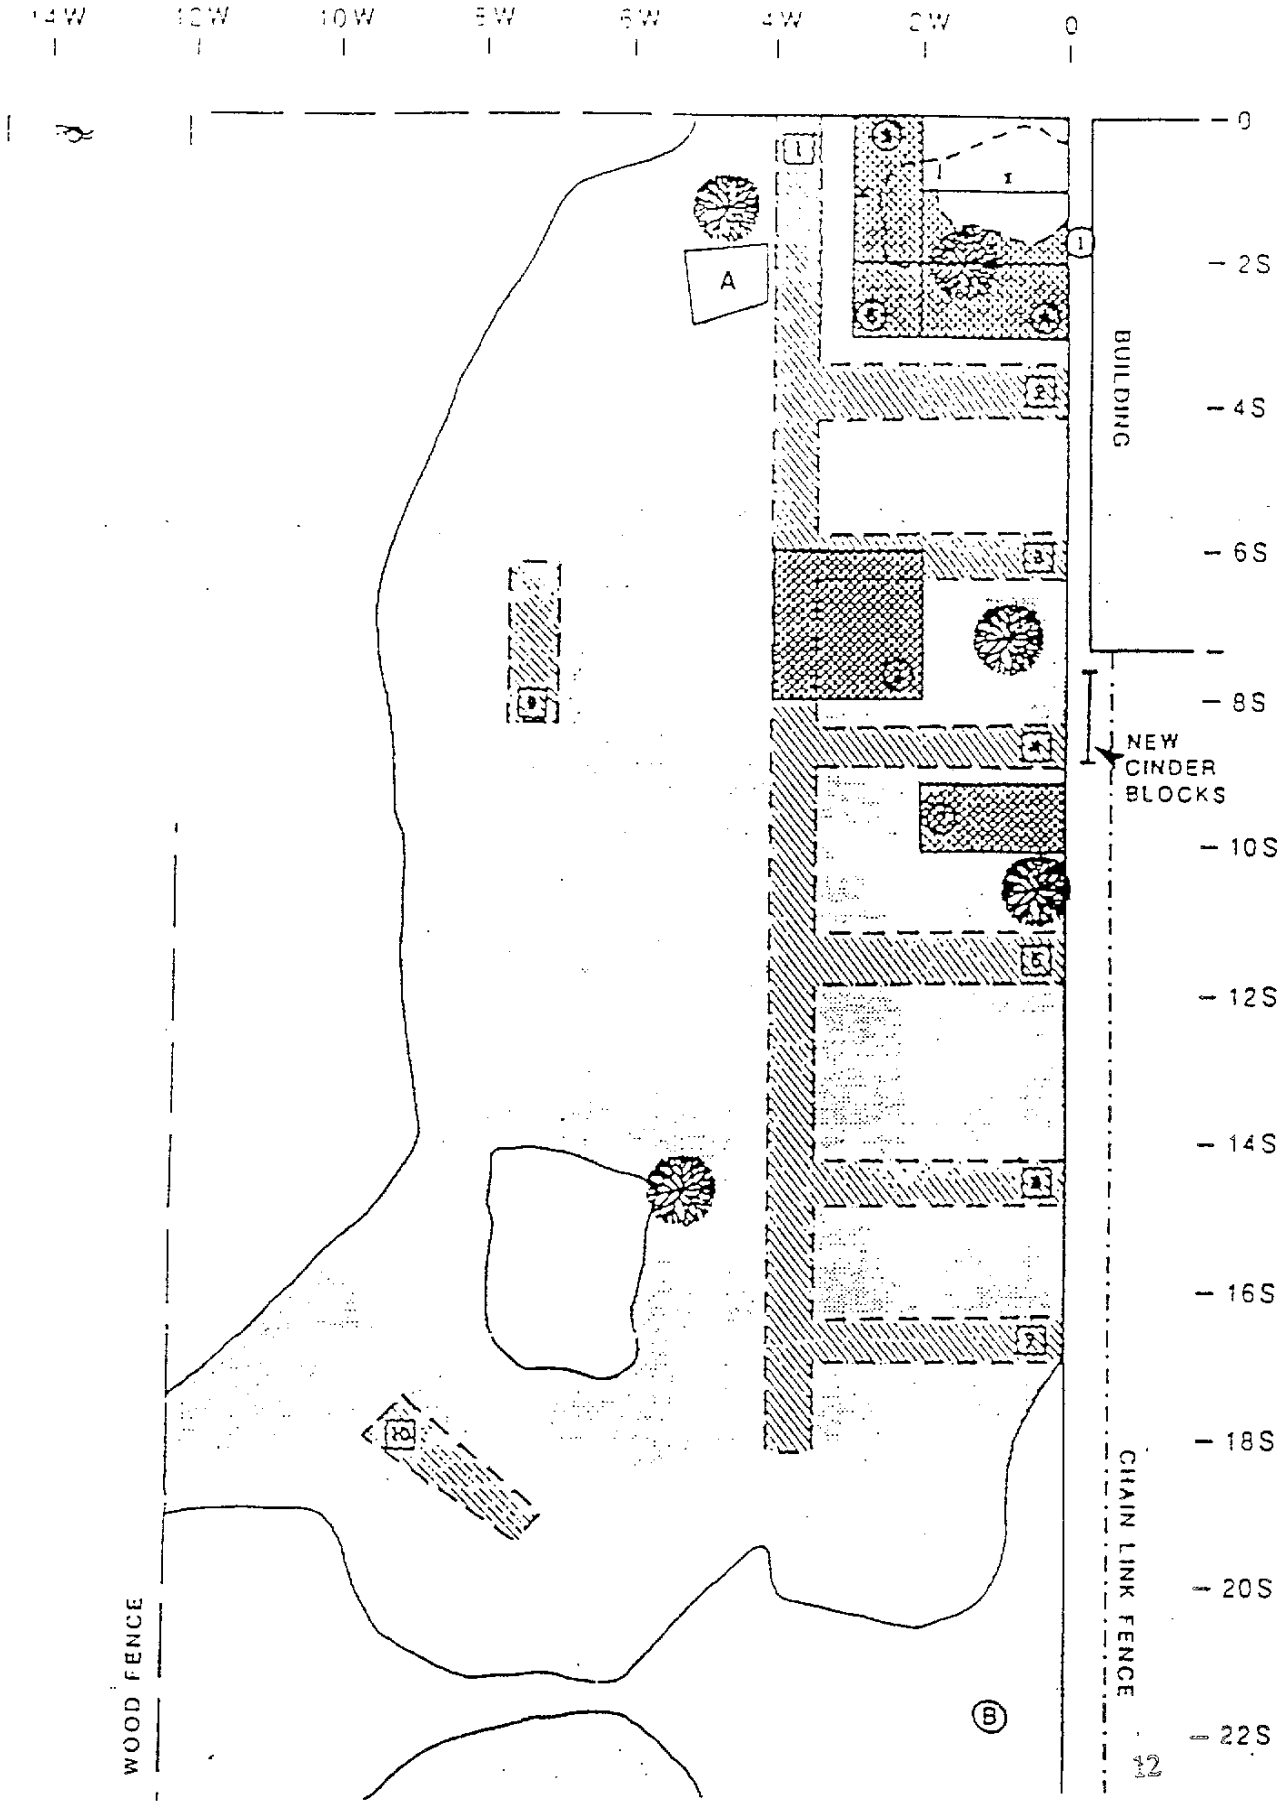
FIGURE 4: DISTRICT ATTORNEY'S ARCHAEOLOGICAL EXCAVATIONS SHOWING UNITS. Note units clustered in NE sector of side lot off room A.

Units 1, 4, 5 (all 1 x 2 m. in size) and 6 (1 x 1 m.) were excavated in the northeastern most part of the lot, immediately adjacent to the west wall of classroom #4 (See Figure 4). Unit 2 (1 x 2 m.) was not excavated. Unit 3 (a 2 x 2 m. unit) was located some 3 m. slightly to the southwest and was placed because "... an entrance [to a tunnel leading to a room] was supposed to be (in the area where Unit 3 was placed" (Langenwalter, 1992b personal communication, see Figure 4 for the location of Unit 3). Also, it should be noted that they dug in that location because "...the area [was also] identified by several children [personal communication, District Attorney's Office] as containing a subterranean room" (see Peter, in Langenwalter, *et al*, 1985: 13). Unit 7 (1 x 2 m) was dug along the preschool play yard fence "Based on the knowledge that people tend to bury animals near to fences, walls, or property boundaries" (see Peter, in Langenwalter, *et al*, 1985: 13).

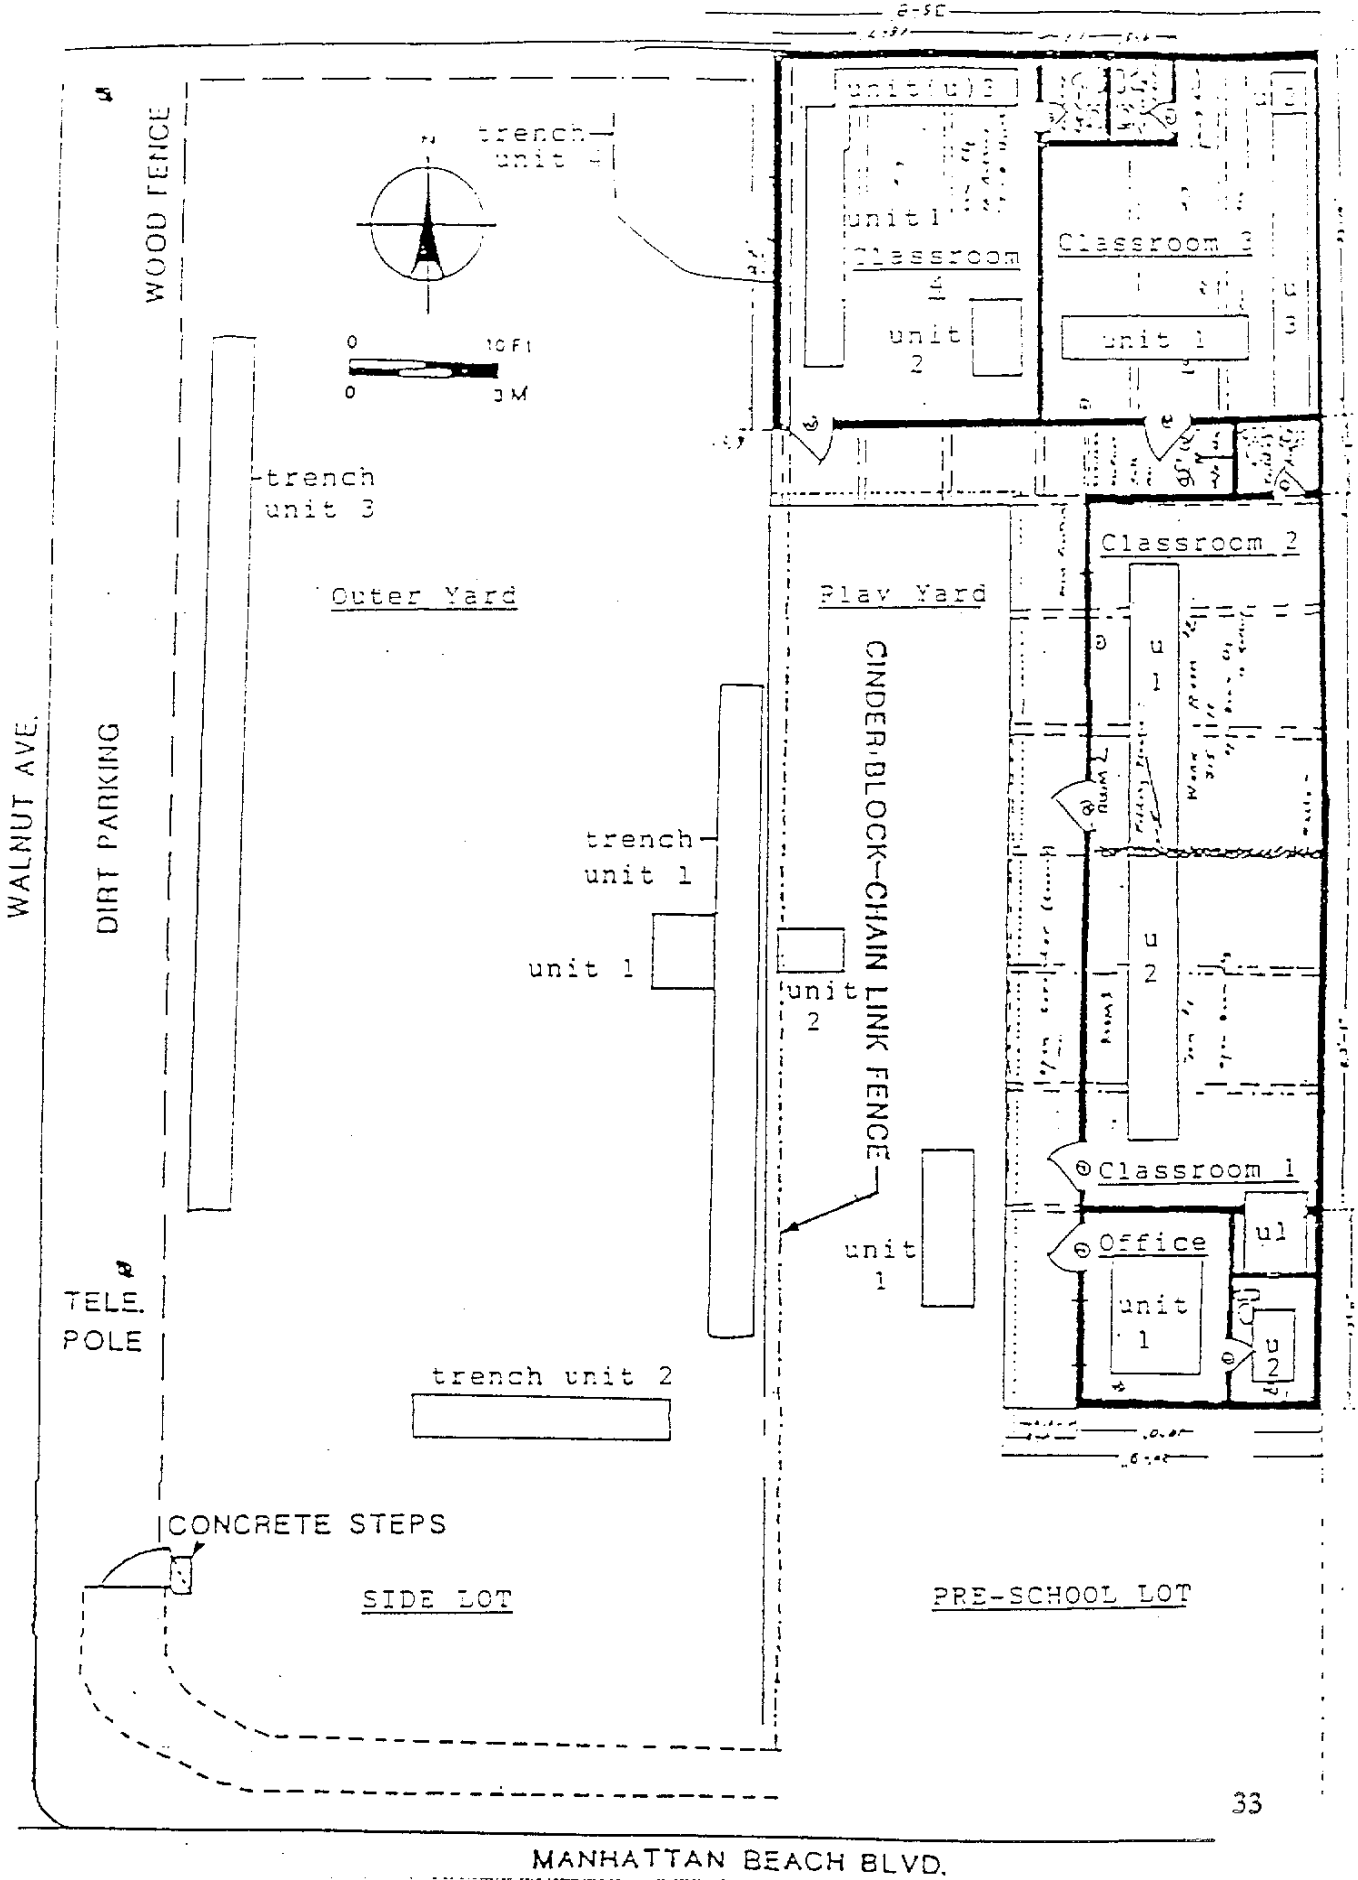
FIGURE 1.1 MAP SHOWING THE TWO LOT SITE AND ALL EXCAVATED UNITS

A permanent Master Datum was established as the northeast corner of the intersection of Manhattan Beach Boulevard and Walnut Street (Figure 11). A Master Datum serves as a point of reference so that all pits/units and artifacts excavated can be measured so their spatial distributions and vertical depths can be reconstructed in later analysis (see Figure 11 for locations of all units and trenches we explored). A secondary site datum was

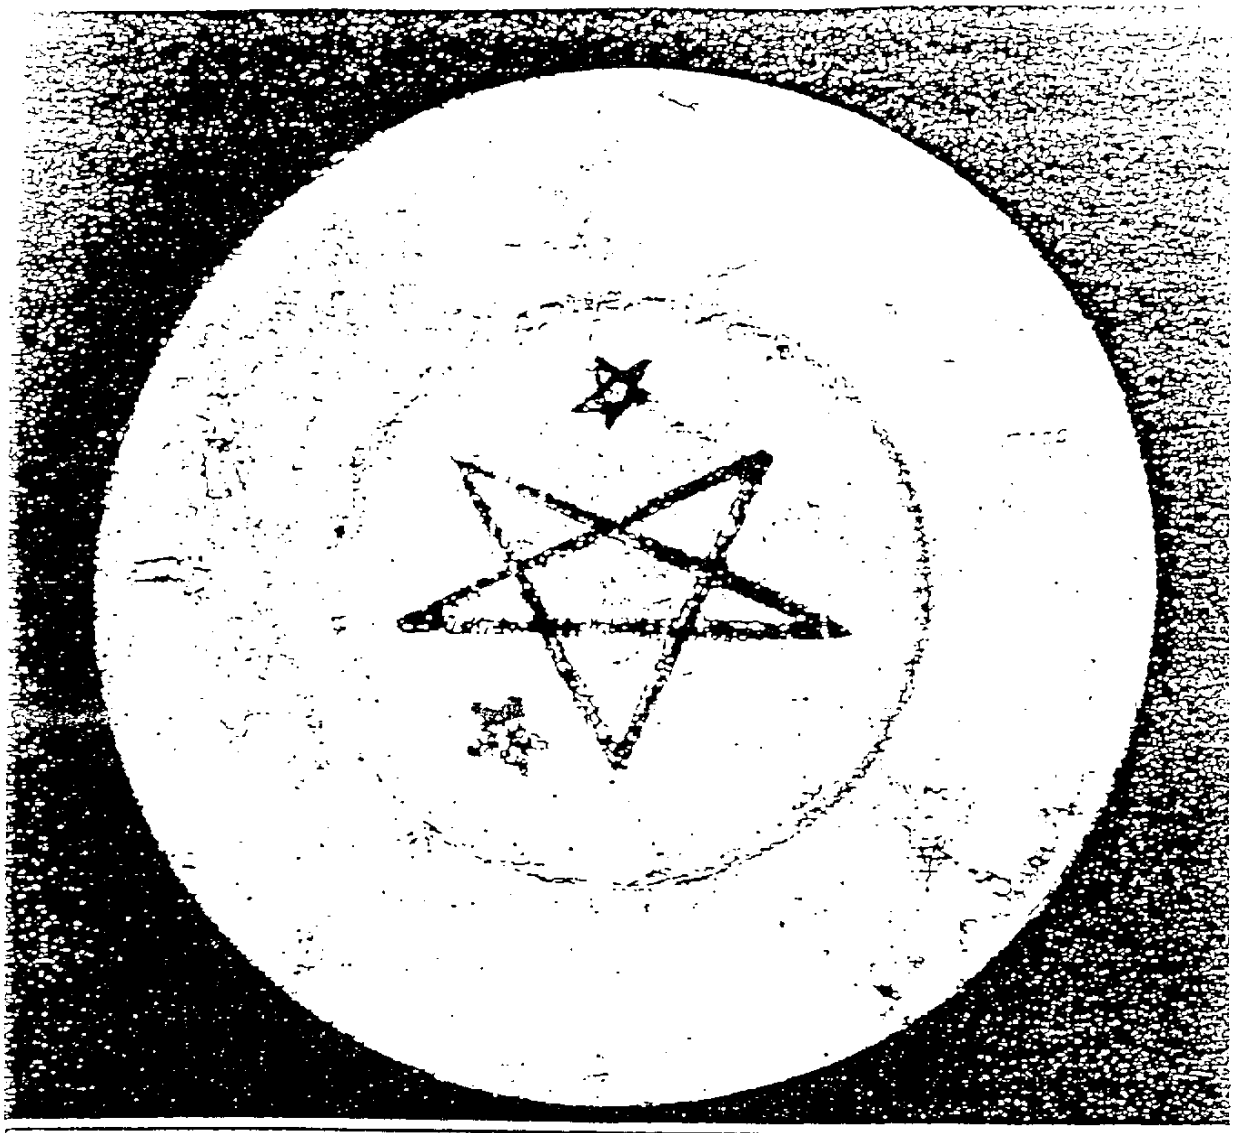
MCMARTIN
PRE-SCHOOL SITE
5-17-90
PLAY YARD
UNIT 2
5 CM

Most pentagrams the author has seen previously were symmetrical (i.e. the star would appear to be balanced from all viewpoints). However this artifact (#MP 2 as it was later catalogued) exhibited a very sophisticated design in that not only is the large pentagram asymmetrical but the two small pentagrams drawn between its starpoints were also drawn in an asymmetrical style (see Figure 16b). This style gives the pentagrams (especially the large one) the appearance of looking "off-balance" from all viewpoints around its perimeter except one. That is, when the large pentagram is viewed from the perspective that has one of the small pentagrams placed at the bottom, the large pentagram then looks "balanced" (see Figure 16b). This indicates that there is a symbolic relationship between one of the small pentagrams and the large one.

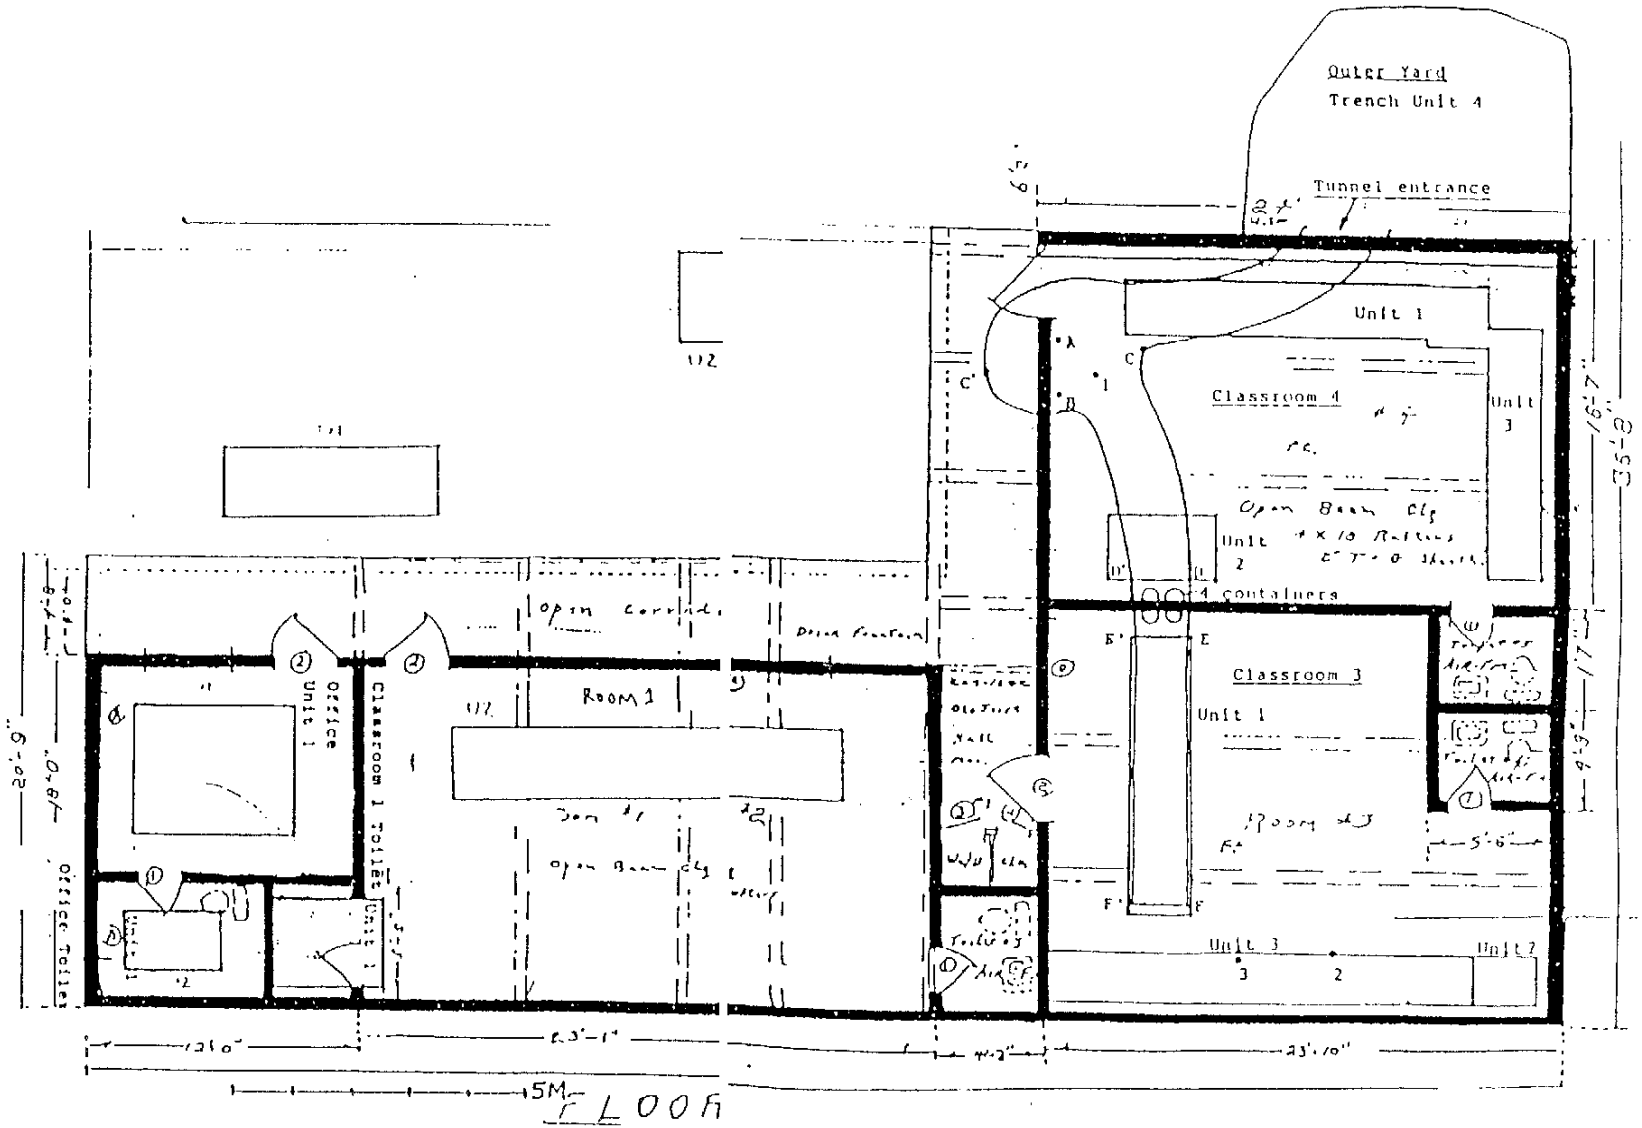
Outer Yard
Trench Unit 4
Tunnel entrance
Unit 1
Classroom 4
Unit 3
Unit 2
4 containers
Classroom 3
Unit 1
Unit 3
Unit 2
Room 1
Office
Unit 1
Classroom 1 Toilets
Office Toilets
5M
FLOOR

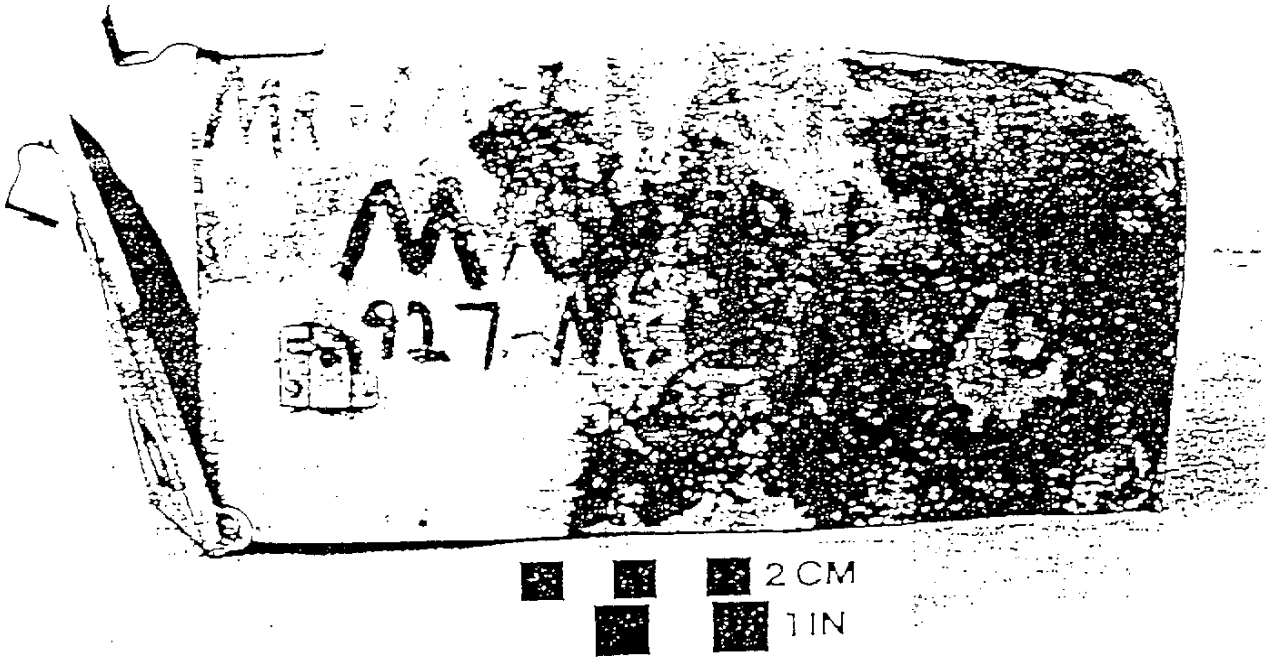
FIGURE 22b: SIDE VIEW OF MAILBOX

One major artifact both in terms of size and potential import, was a complete rural, roadside style mailbox with a rounded top and a mail-for-pickup metal flag indicator (the actual flag was missing but the holder for the flag was present on the side of the box). The mailbox measured 48 cm. (19") long x 17 cm. (6.75") wide x 24 cm. (9.5") in height. This mailbox had the name "Mr. and Mrs. Karl Morris" and "927 M.B. Blvd." painted on one side, the same as the last occupants of the house on the adjacent lot that was torn down in 1972 (Figure 22a). On the other side was painted "Morris 927 M.B. Blvd." The mailbox door also was painted with "927 MB Blvd" (Figure 22b). This artifact was found in the east extension of Unit 1 (see Figure 20b, point 1) which placed it southeast of the southeast corner of Unit 1 and in the middle of the tunnel heading northeastward.

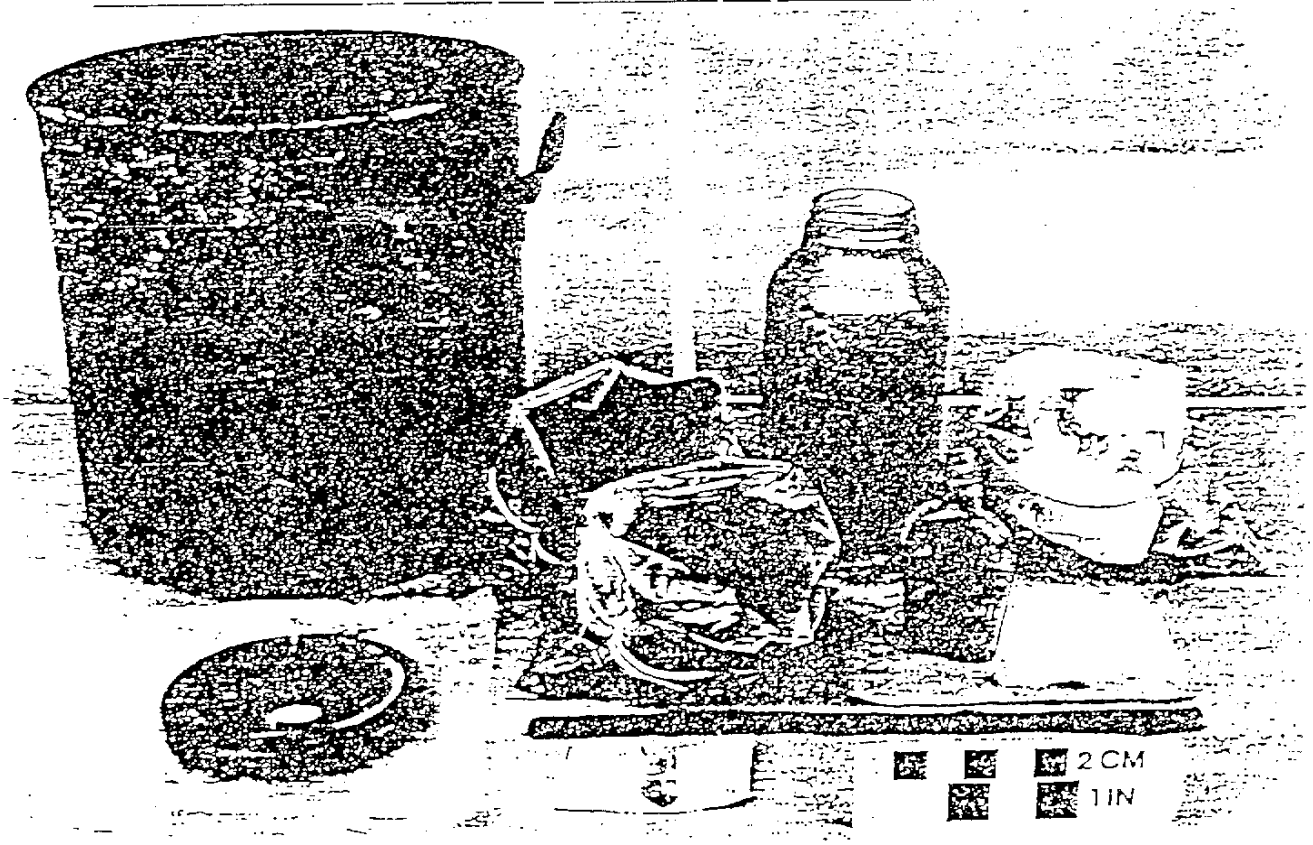
FIGURE 306: TALL METAL CONTAINER AND CONTENTS

All four containers were found filled with a great deal of trash (Figures 30a-d). The cast iron caldron was filled mainly with soil but it did contain 2 metal fragments, a piece of black yarn and 2 large fragments of an ocean shell (wavy top shell, *Astrea undosa*, Figure 29). The smaller of the two blue enameled metal pots contained a large fragment of a soft drink bottle, 60—80 miscellaneous metal fragments, 3 light green-painted cinder block fragments, and one small bone china pot lid (Figure 30c). The larger of the two cylindrical blue metal pots contained one large 1 gallon glass food jar (found completely unbroken), 35—40 old rusted tin can fragments, one 15 cm. (diameter) crockery lid, one old medicine bottle, 30—33 glass fragments from a large jar, one small, pestle-like stone and one 43 cm. (17") rusted metal rod (Figure 30d). The tall crockery pot contained 1 chunk of concrete (15.5 x 13 cm.) and 60—70 rusted metal can fragments (Figure 30b). All items were packed with soil in each container.

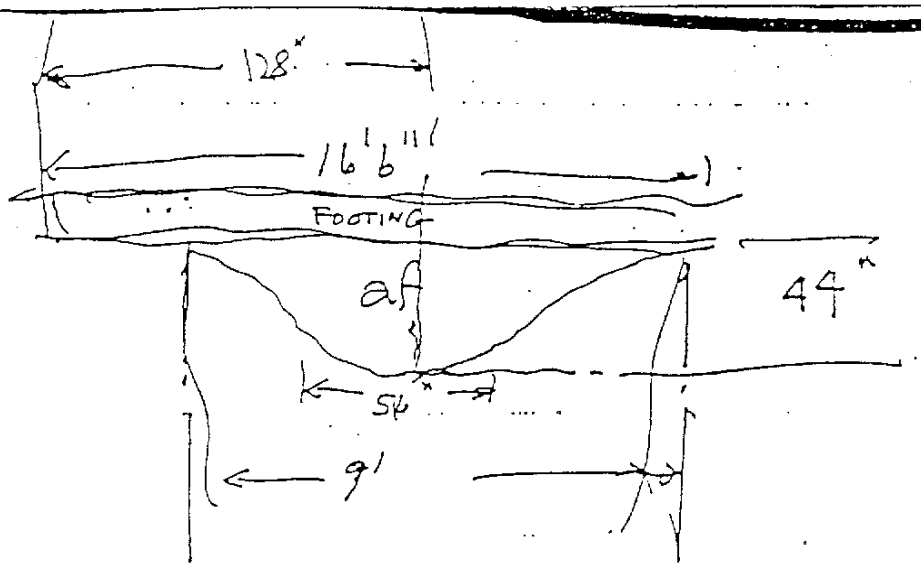
I. 3b Drawing by E.D. Michael. Referred to in ~~text~~ [illegible]

Dr. Michael also provided a drawing (Figure 18a) and measurements of a feature he described as a cavity. This feature was located under the foundation of the west wall of Classroom #4. Although initially discussed in a 1992 correspondence to the author (Appendix I.3a), upon an inquiry seeking clarification of his report, Dr. Michael now reports that the feature was a "cavity" which contained "af", that is "artificial fill" that had been emplaced ". . .due to the operations of man. . . ". He reports that the cavity could have been formed in three ways:

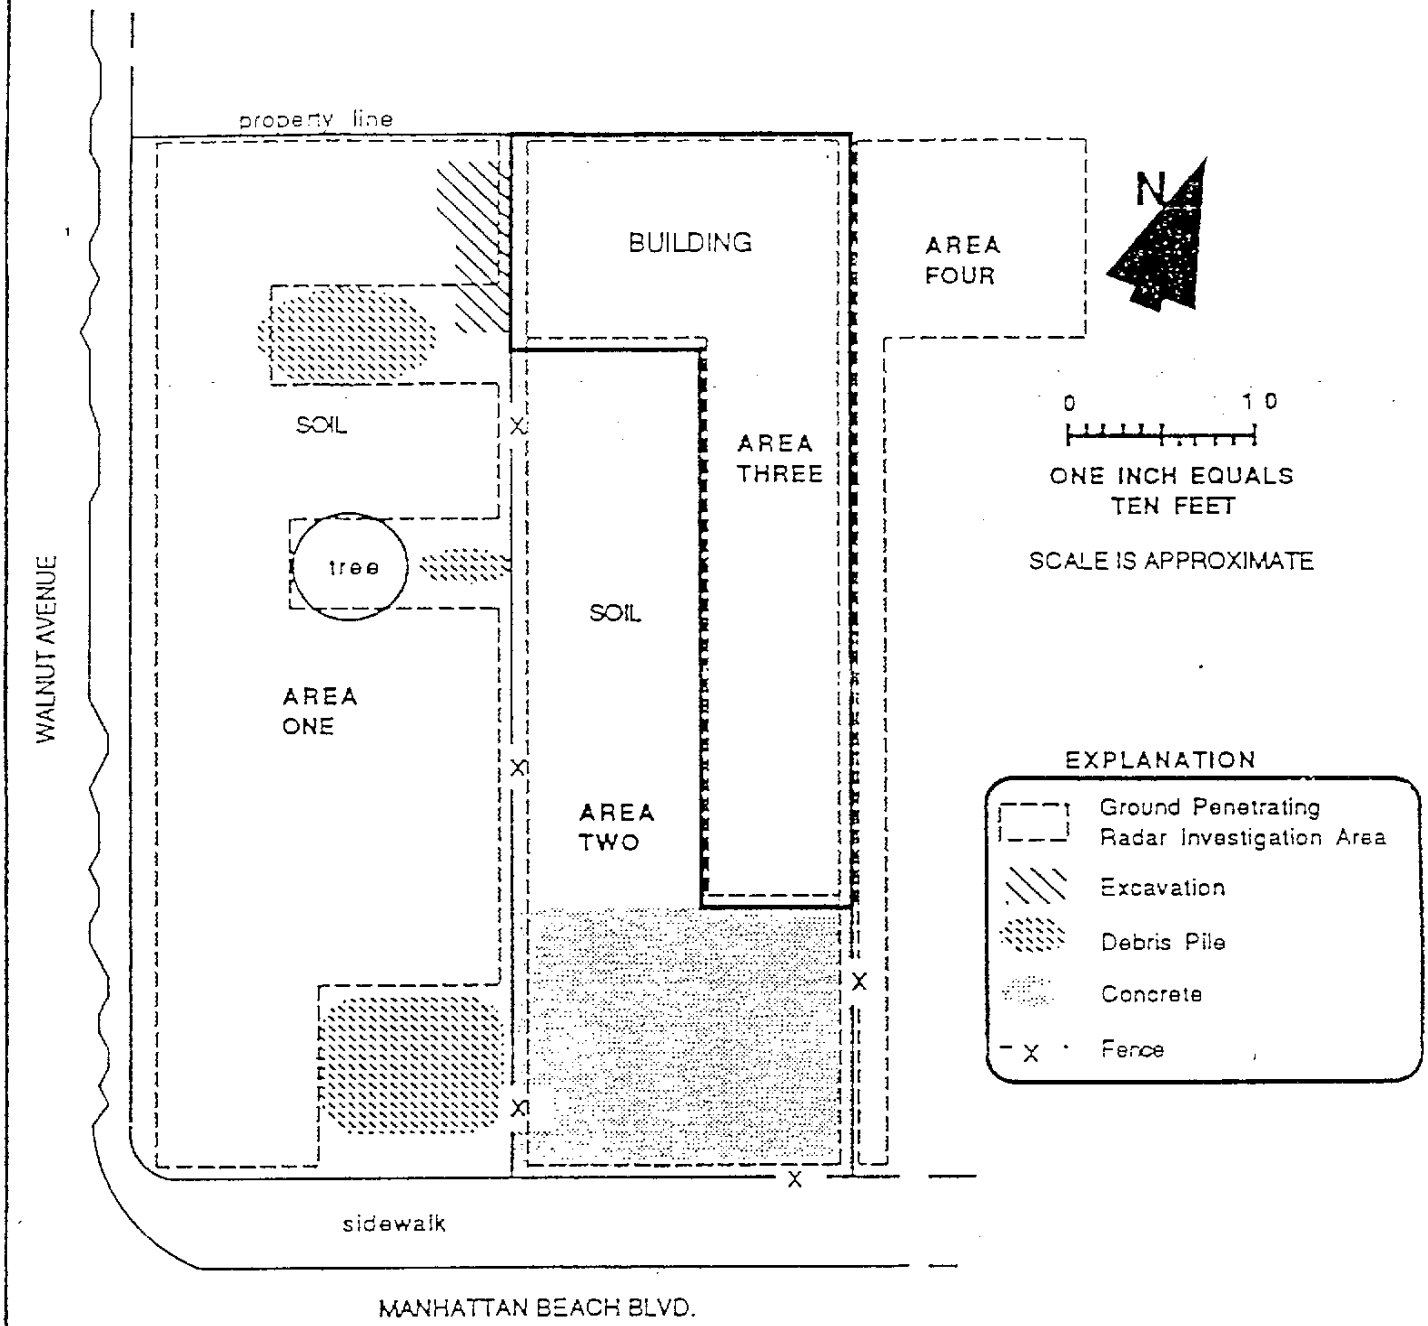
90051101C
J. LeTourneau
Date of Investigation:
11 May 1990

*Not all below ground facilities may be represented on this map.

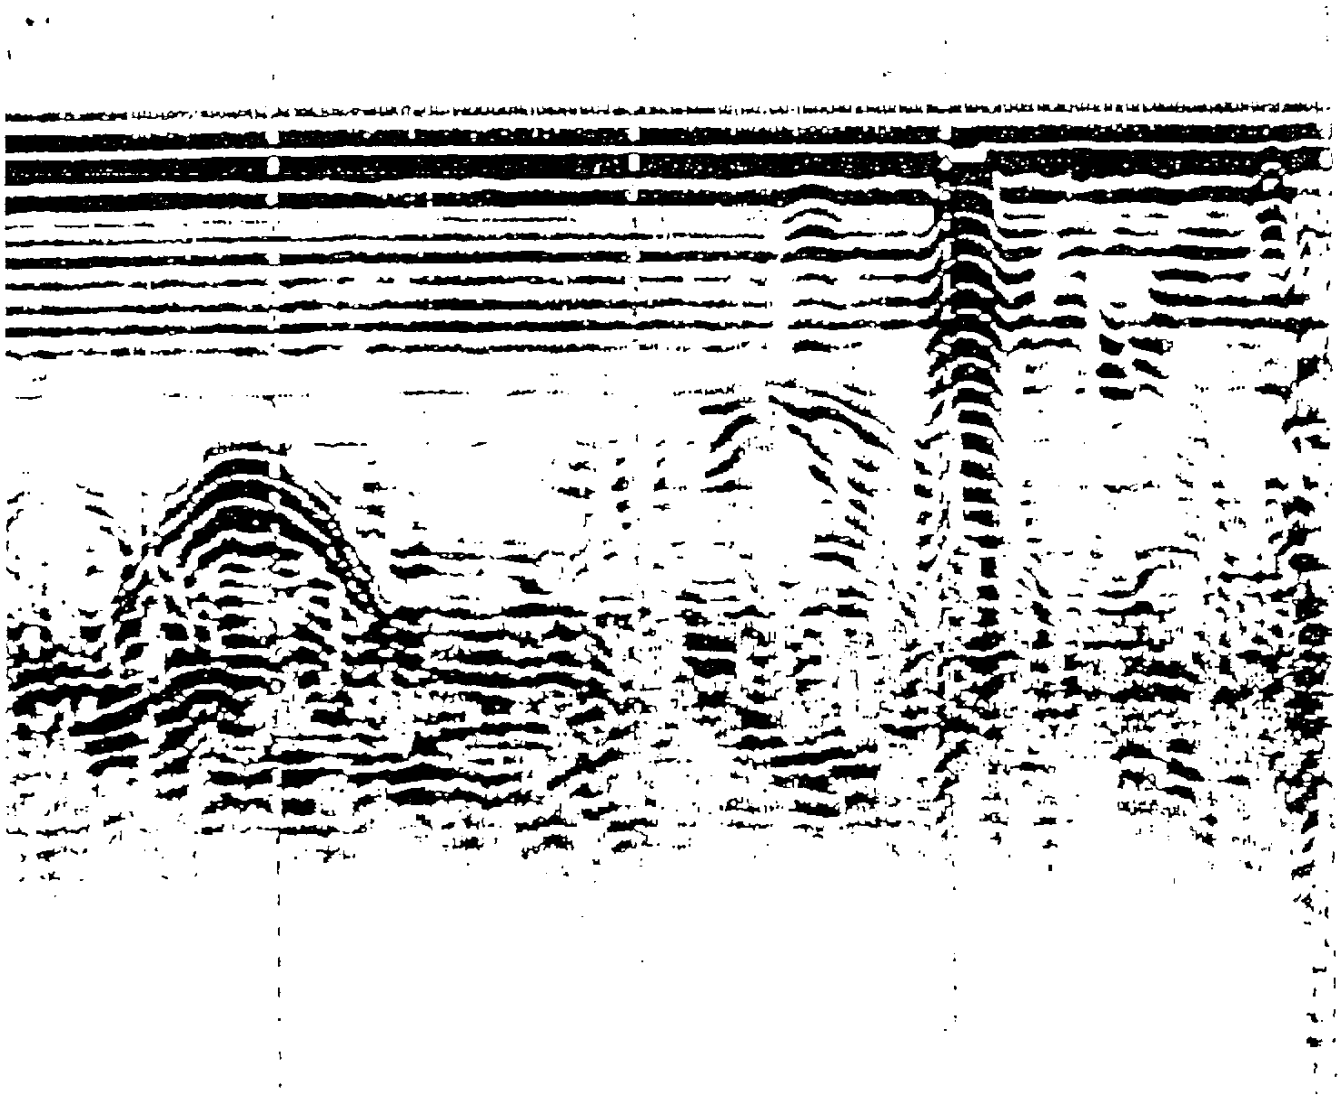
Typical ground penetrating radar profile from Area One

10 feet between vertical dashed lines

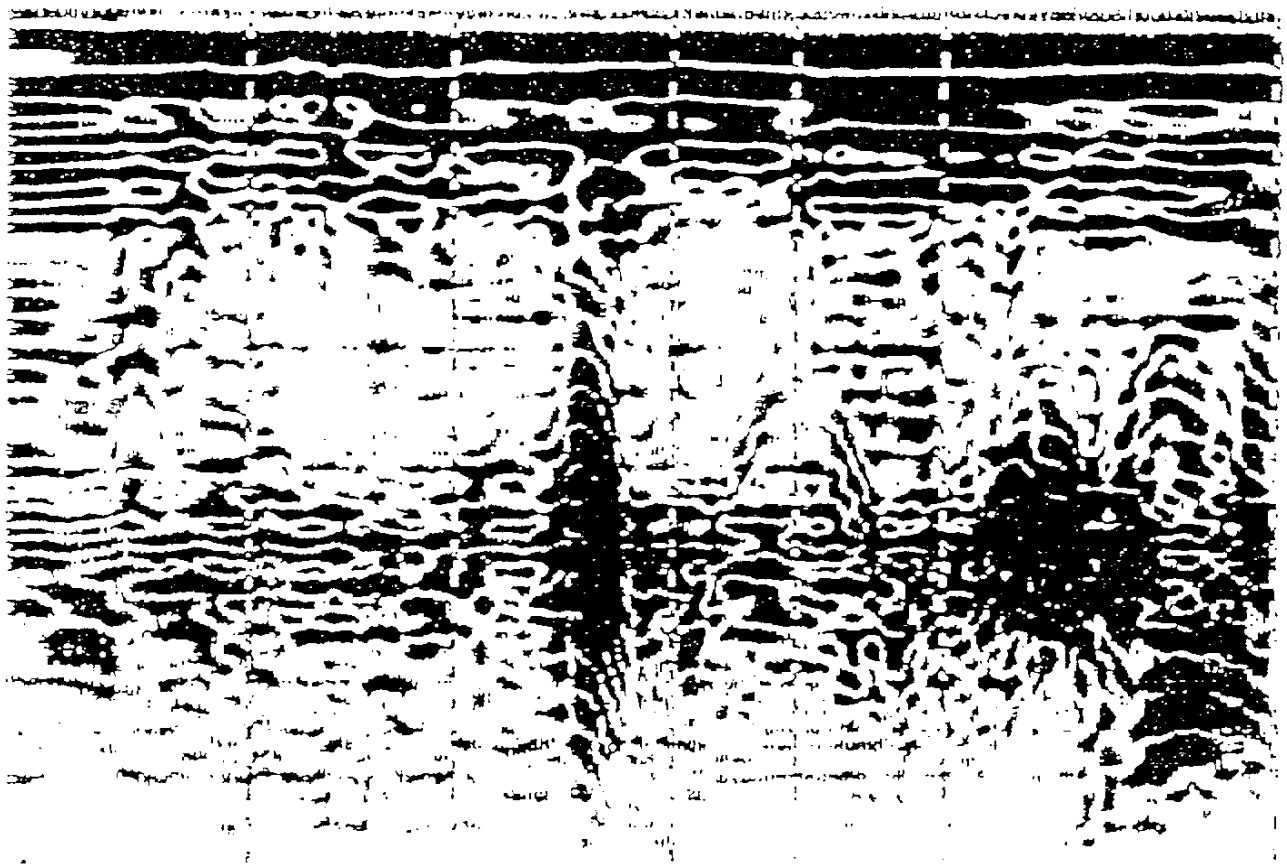
Typical ground penetrating radar profile from Area Two

5 feet between vertical dashed lines

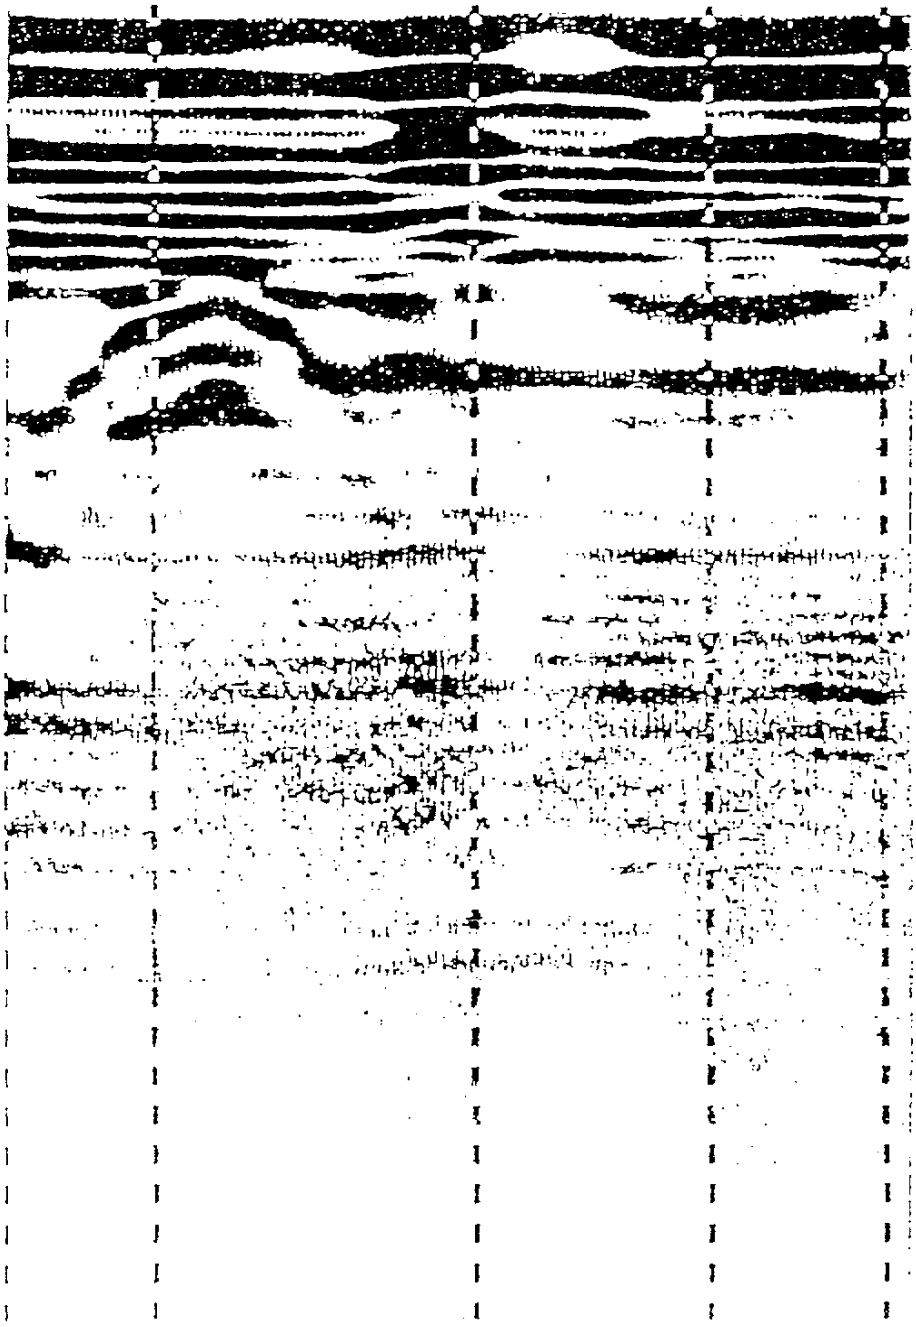
Typical ground penetrating radar profile from Area Three

5 feet between vertical dashed lines

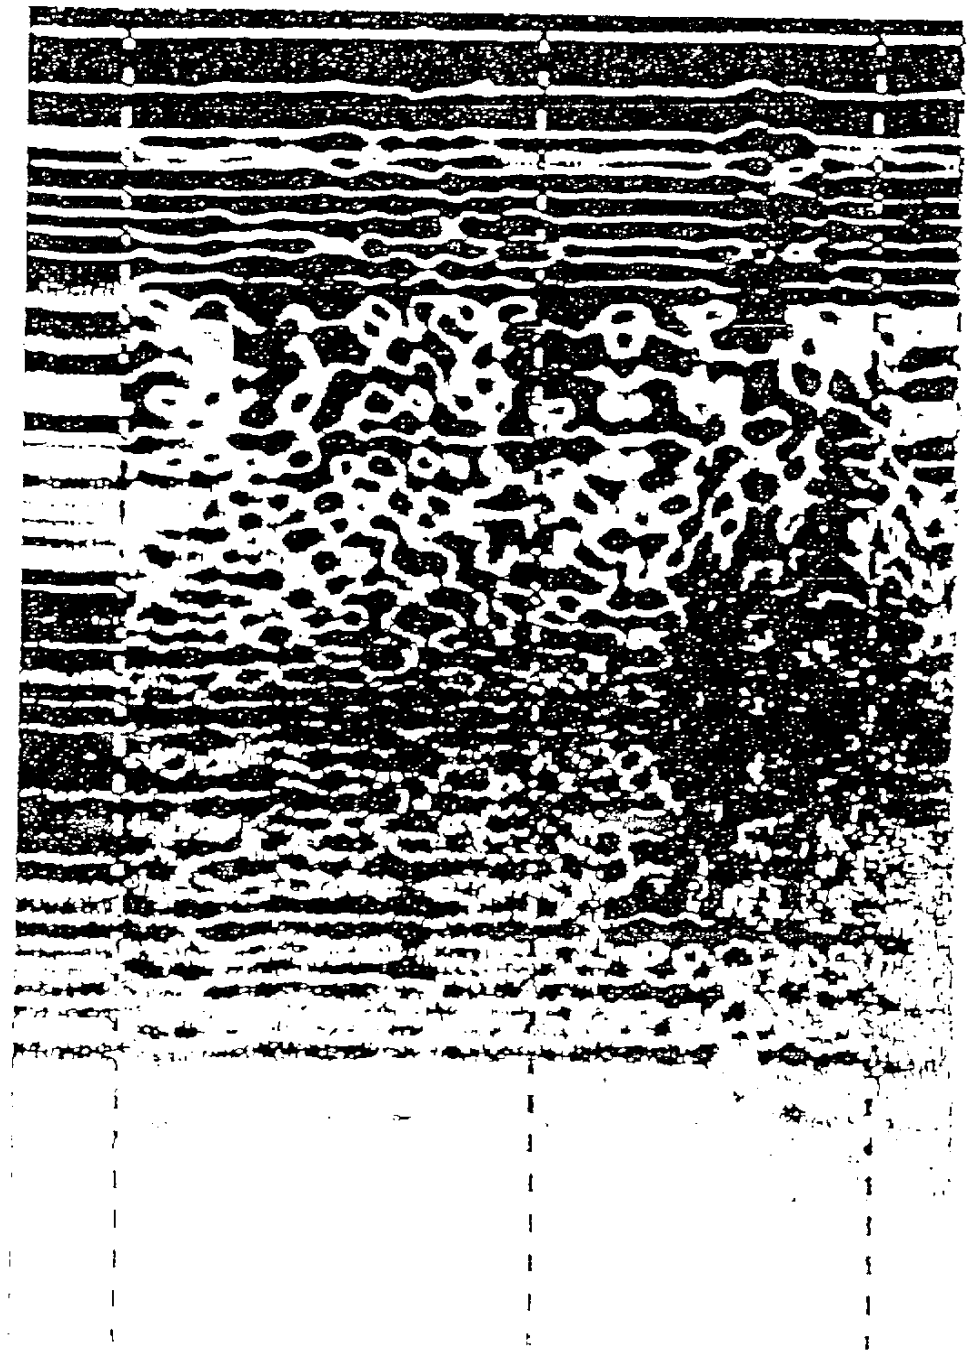
Typical ground penetrating radar profile from Area Four

10 feet between vertical dashed lines
